BUILDING CONCEPTS

CANYON ARTS & INSPIRATION (MAINTENANCE BUILDING)

LIVERY BUILDING

BLACKSMITH BUILDING

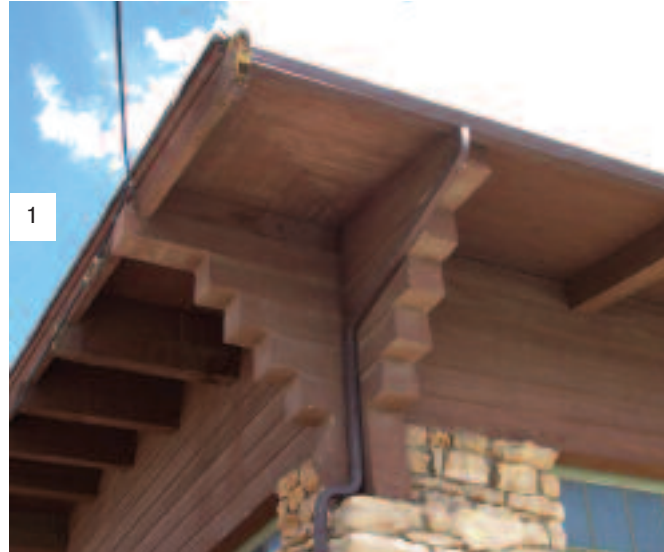
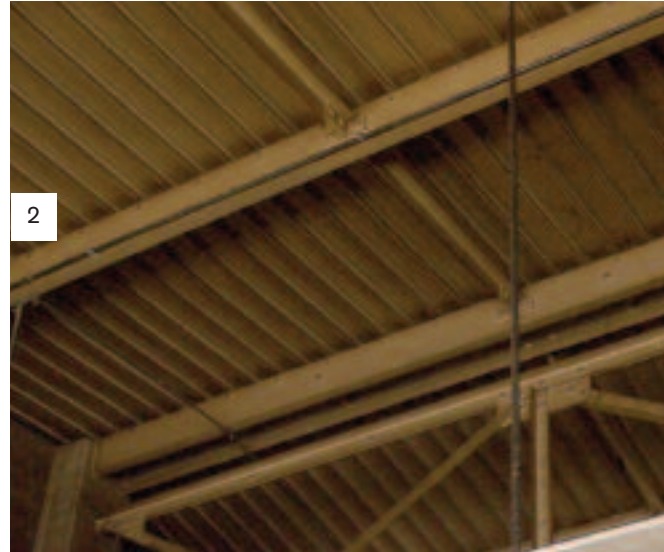
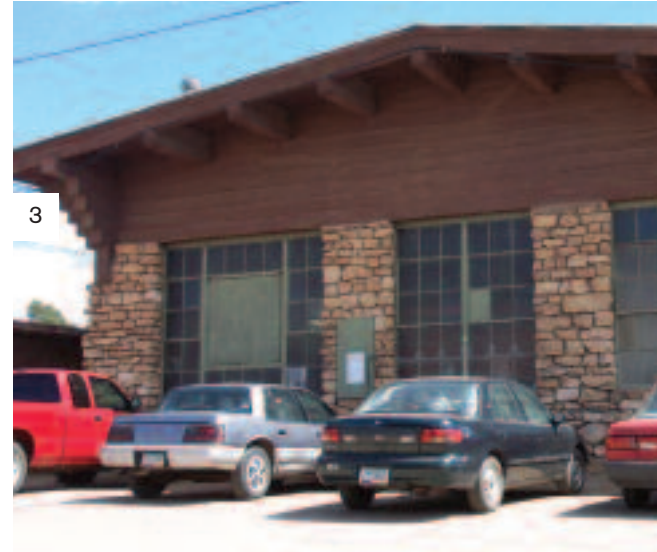
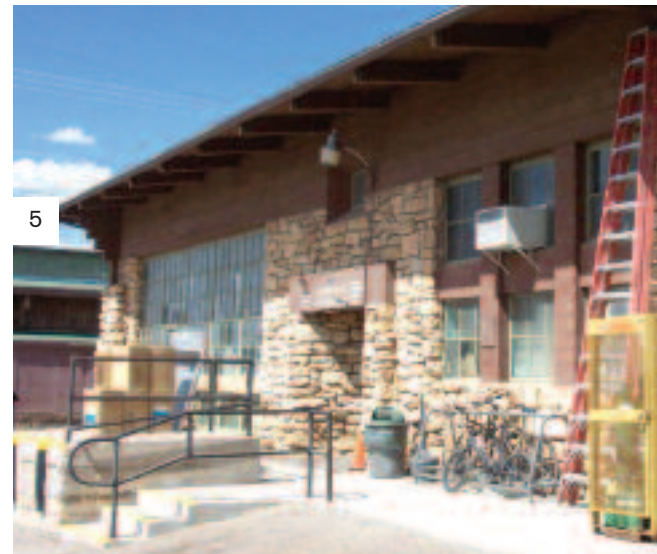
- 1 Eave Detail
- 2 Ceiling Construction
- 3 Exterior Facade
- 4 Ceiling Structure
- 5 Existing Entry

The Maintenance Building (Canyon Arts & Inspiration) is a one-story structure of mixed construction. The roof consists of steel trusses spanning to perimeter concrete bearing walls and is sheathed with metal deck. The foundation appears to be concrete spread footings around the perimeter. The lateral force resisting system is classified as concrete shear wall. A concrete block addition is located on the south side of the building.

We would expect the building to perform well in a moderate earthquake, providing a life-safety level of performance with some seismic upgrade. The roof diaphragm has an aspect ratio of about one to one and a half and there appears to be an adequate amount of shear wall in each principle direction. The existing connection between the concrete walls and the roof will likely require strengthening by the addition of new anchors. The connection between the concrete walls and the foundation should be verified, we do however expect that reinforcing dowels are present. The new use of the building includes the demolition of the building addition. If the addition remains, strengthening may be required.

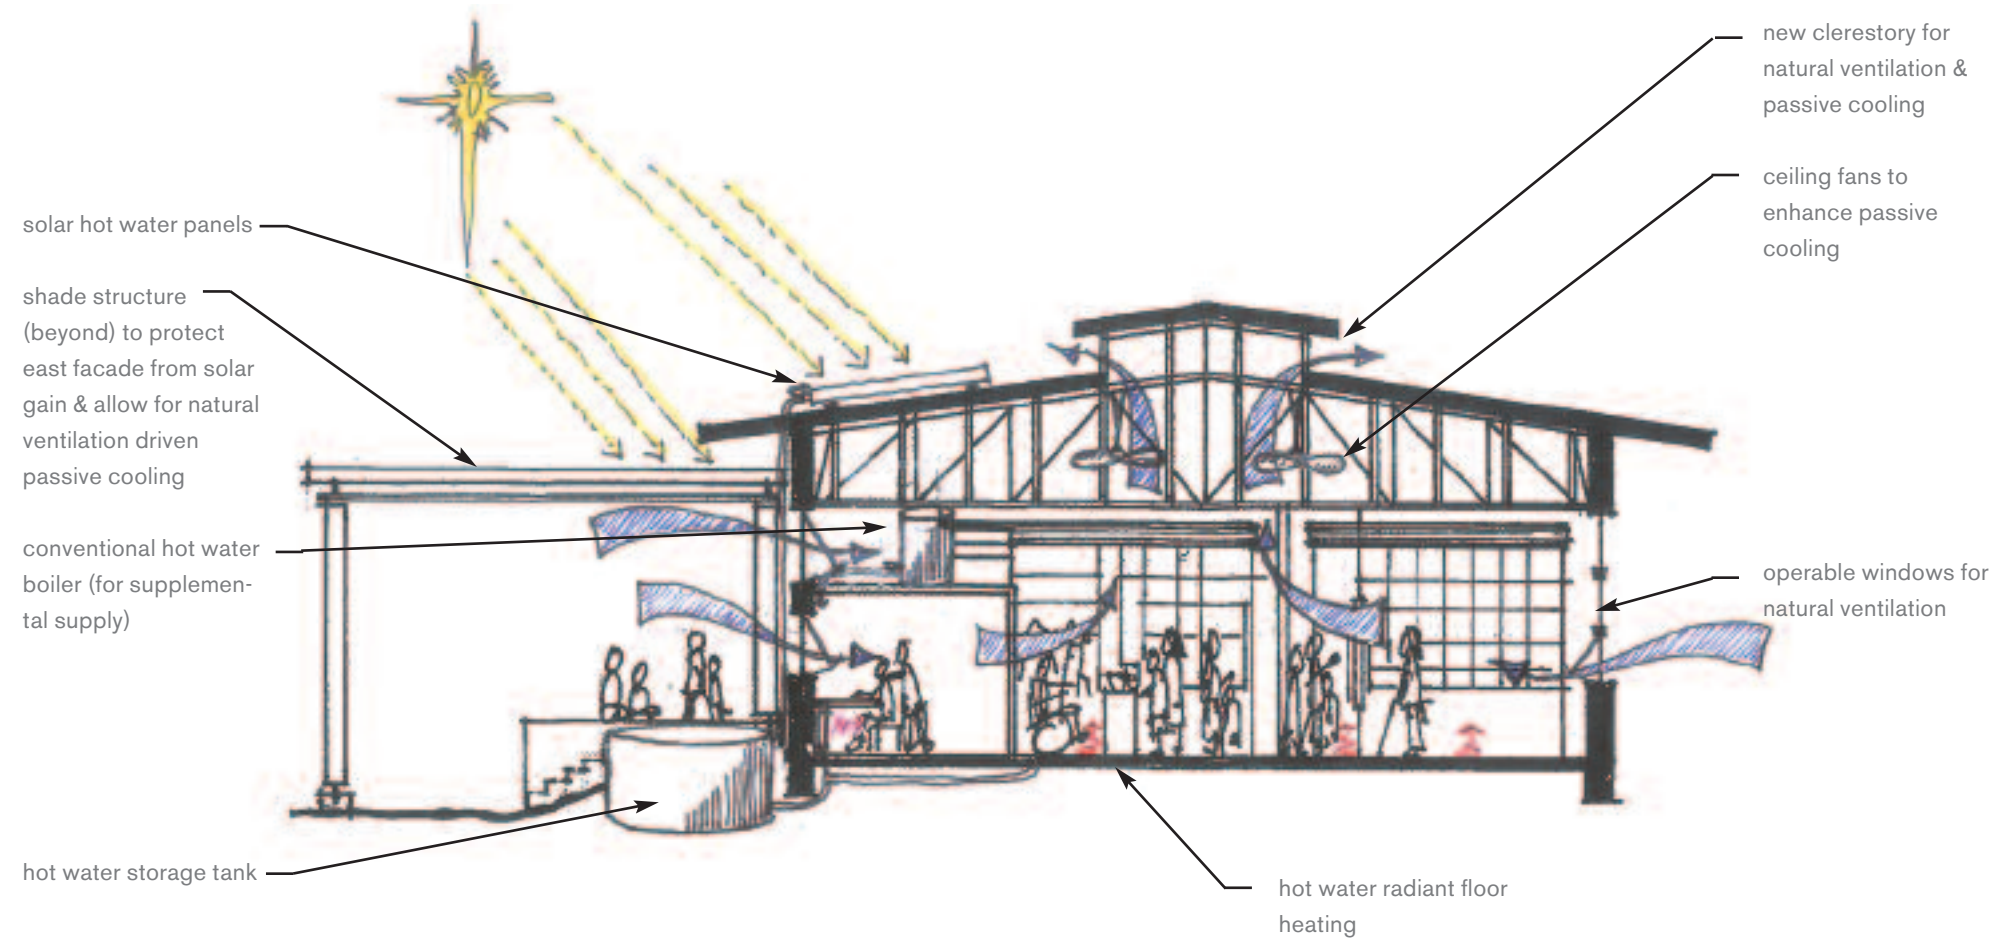
MAINTENANCE BUILDING (CANYON ARTS & INSPIRATION) SECTION HEATING & COOLING DIAGRAM

Again, to minimize the impact to the historic building character, modification to the envelope of this structure is limited to the addition of a roof ventilation clerestory. This clerestory would be similar in form to the one on the laundry building, and would be accomplished as a part of the required re-roofing of the structure. This would allow for a similar naturally ventilated cooling strategy as proposed for a number of the other buildings.

Passive cooling will be provided using natural ventilation through a combination of operable windows and stack effect using the proposed roof clerestory. Passive heating is proposed to be provided using solar hot water heating panels located on the south facing portion of the roof coupled with a hot water storage tank and radiant floor slab distribution where appropriate, and wall mounted radiator panels in areas (such as toilets) where radiant slab distribution is less appropriate or cost effective.

Supplemental cooling will be provided by appropriately located ceiling fans (to enhance the natural stack system). Supplemental heating will be provided by coupling a high efficiency, gas fired condensing boiler for any required 'top-up' to the solar hot water storage and distribution loop.

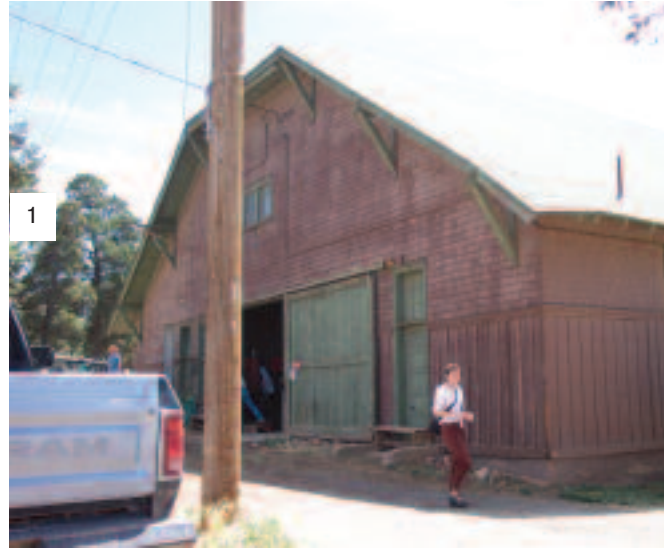
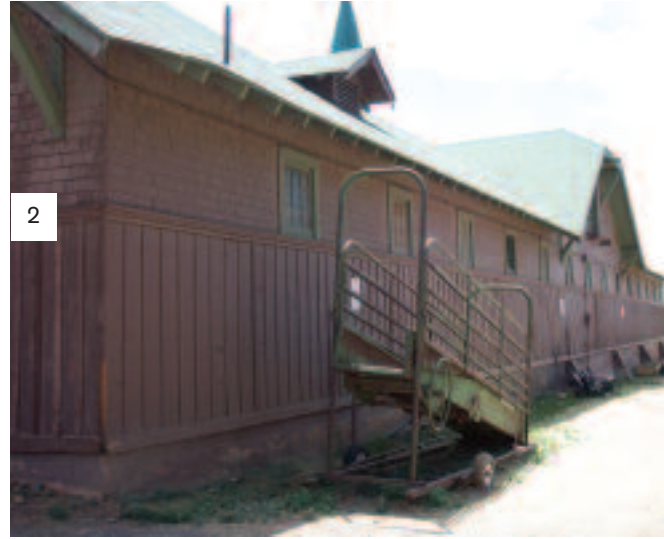
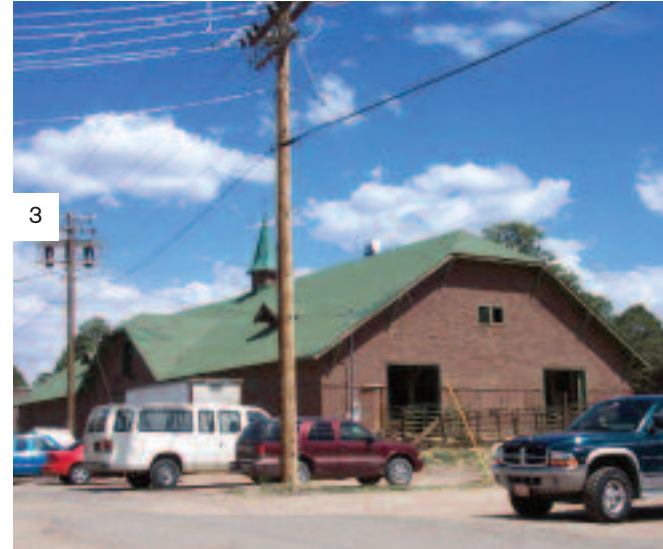
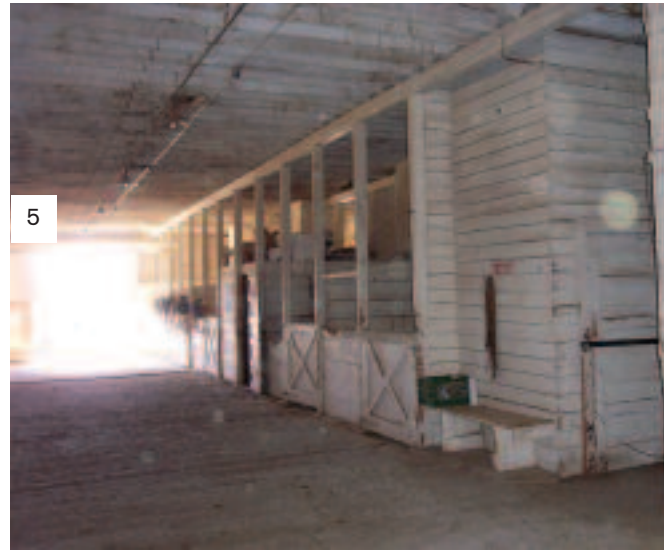
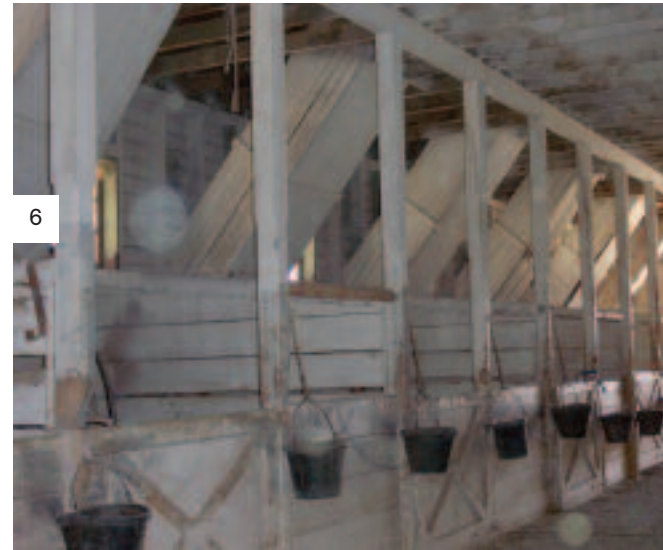
- 1 East Entry
- 2 North Facade
- 3 View from Northwest
- 4 Structural System
- 5 Interior View
- 5 Mule Stalls

The Livery Stable is a one-story structure, with attic loft, of wood frame construction. The roof consists of wood trusses spanning to perimeter wood stud bearing walls and interior post and beam frames. Both the roof and walls are sheathed with straight sheathing. The foundation appears to be concrete spread footings at the perimeter and isolated spread

footings at interior posts. The lateral force resisting system is classified as wood shear wall. In our site visit we were unable to verify the connection between the wood shear wall system and supporting spread footing foundation due to 1x straight sheathing applied to the inside face of studs.

We would expect the building to perform well in a moderate earthquake, providing a life-safety level of performance with only a minor amount of upgrade. The roof diaphragm has an aspect ratio of about two to one and there is a generous amount of shear wall in each principle direction. A connection between the roof and the walls does not appear to exist and the addition of new 2x blocking tied into the roof diaphragm and wall double top plates is recommended. In addition, the connection between the walls and foundation should be verified, however, we would expect that additional anchor bolts will be required.

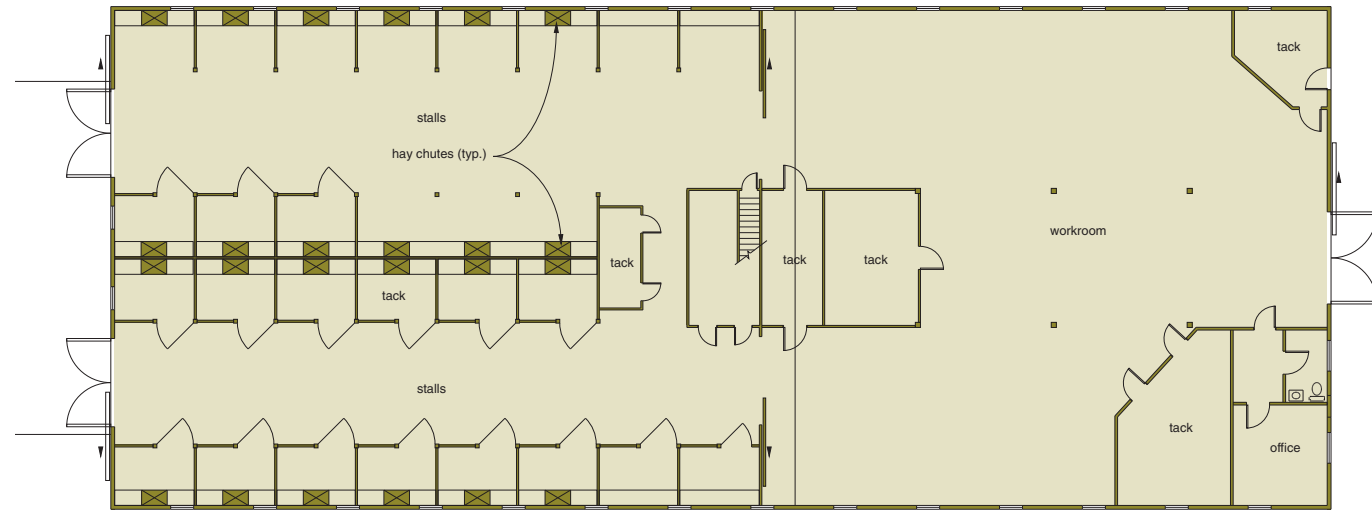
LIVERY STABLE GROUND FLOOR HISTORIC PRESERVATION DIAGRAM

- important character-defining features
- original fabric
- spaces undergoing significant alteration

As part of the “Working Zone” of the proposed Grand Canyon Village Interpretive Center, the Livery Stable will continue to fulfill its historic function. Aside from resolving structural and aesthetic issues brought on by deferred maintenance, very few changes are proposed for the building, which will continue to house the mules that take visitors into the Grand Canyon. As part of the Grand Canyon Village Interpretive Center, the Livery Stable will be given a more prominent role in the visitor experience. The outdoor corral will be reduced in size slightly and natural landscape and rock terracing placed between the visitors and the mules in order to prevent errant mule bites and inappropriate food being slipped into the corral.

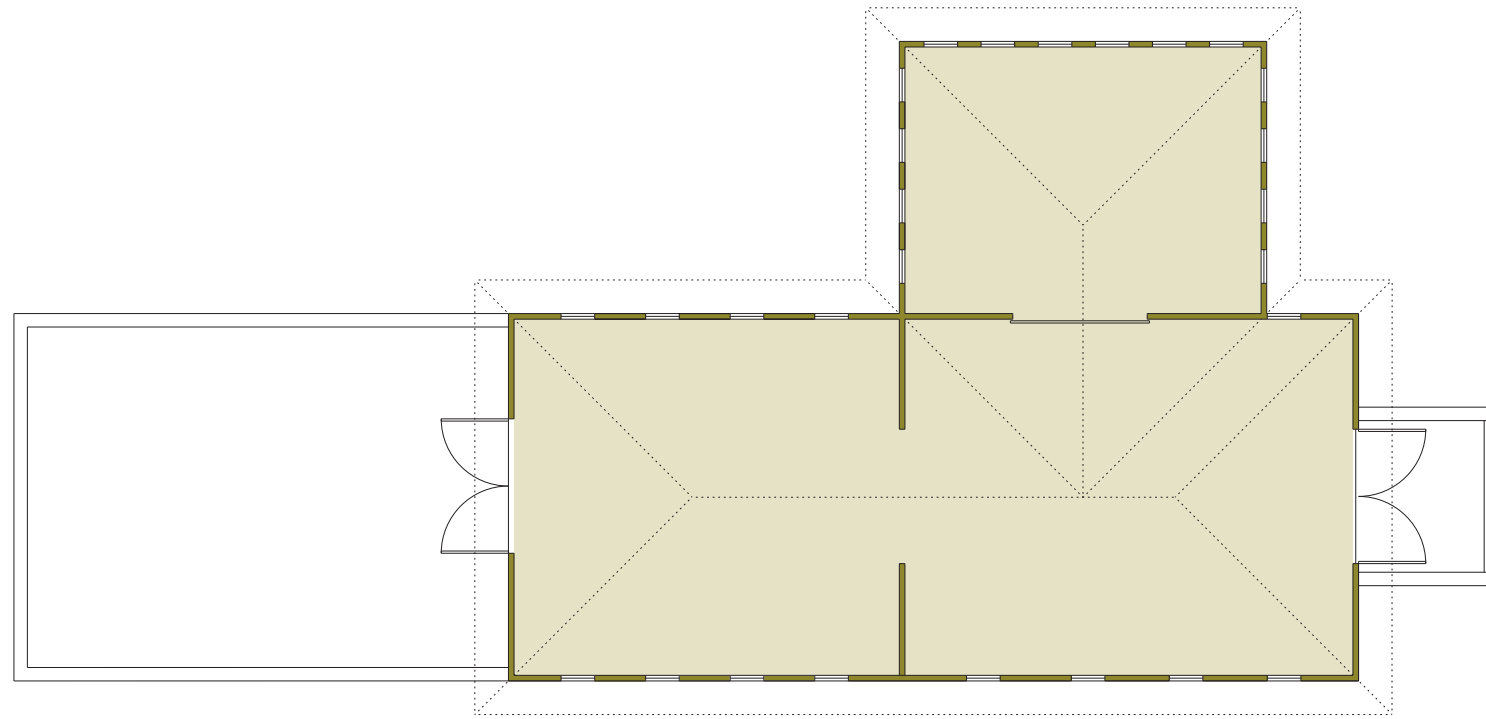
BLACKSMITH GROUND FLOOR HISTORIC PRESERVATION DIAGRAM

This use of the building will trigger ADA and life-safety code issues relating to public occupancy, necessitating the repair of all exterior doors to make them operable and the creation of an unobstructed path of travel from the parking lot into the building. In addition, any structural or material-related issues will need to be resolved.
